FIELD INVESTIGATION OF BRICK VENEER/STEEL STUD WALL SYSTEMS

SUBMITTED BY: SUTER KELLER INC
1390 PRINCE OF WALES DRIVE
OTTAWA, ONTARIO
K2C 3N6

DATE OF REPORT: NOVEMBER 30, 1989

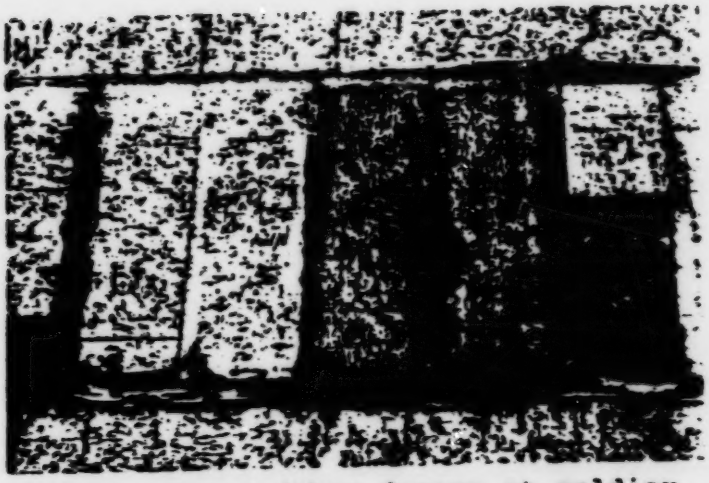
The condition of the brick veneers ranged from satisfactory to poor in some buildings. Typical examples of distress are depicted in Figs. 3 to 6. Masonry workmanship for the 8 buildings was considered average for residential

Fig. 3 Freeze/thaw damage at soldier course

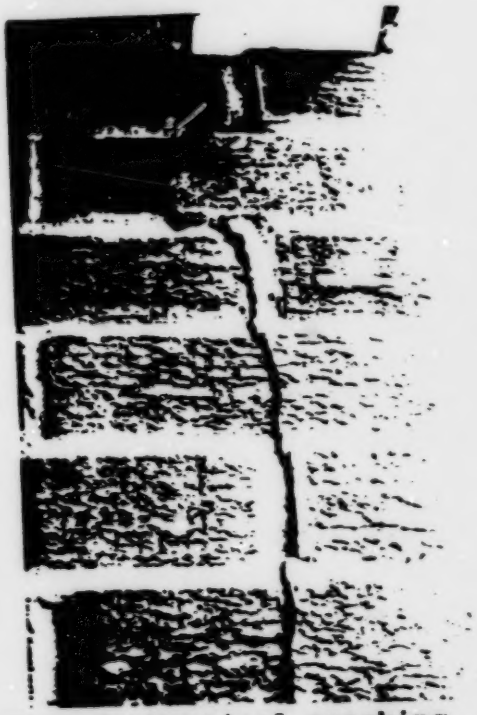
Fig. 4 Vertical cracking due to unintentional load transfer at balcony

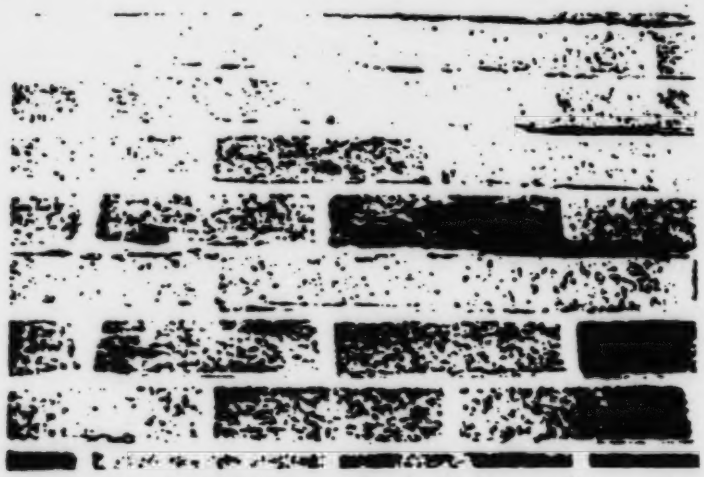
Fig. 5 Spalling of brick units at shelf angle location due to lack of a "soft" joint

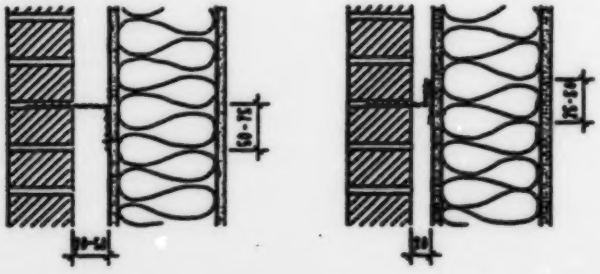
Over 60% of the buildings investigated utilize strip ties to fasten the brick veneer to the steel stud wall. The remainder used adjustable type ties directly screwed onto the stud flange. The strip tie installation was generally poor with ties being frequently bent up or down to suit the installation as shown typically in Fig. 9.

Fig. 9 Frequent strip tie installation

The condition of the brick ties varied from building to building. Strip ties generally showed corrosion at the brick/cavity interface or where in contact with mortar, i.e. if covered with mortar droppings as seen typically in Fig. 10. Adjustable ties were generally in satisfactory condition but corrosion was also evident in some instances especially at the brick/mortar interface.

- The practice of using ordinary strip ties to fasten the brick veneer should be discontinued. It is noted here that CSA Standard CAN3-A370-M84 (1) does not permit the use of standard corrugated strip ties to connect brick veneer in buildings exceeding 11 m (36 ft.) in height.

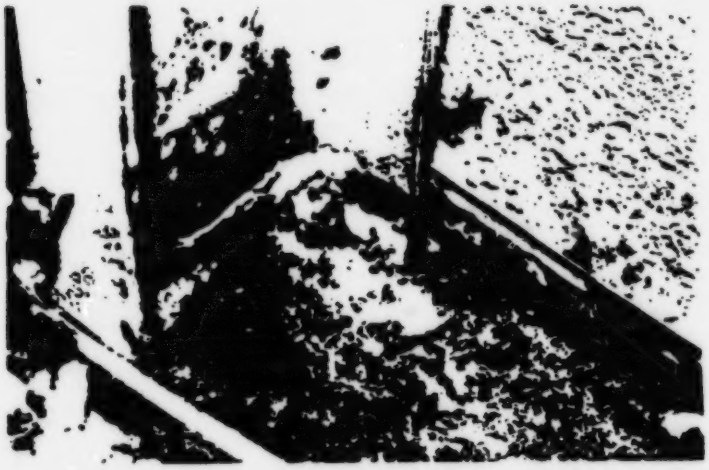
In general, steel studs were found to be in satisfactory condition. Only traces of corrosion were noticed in some cases except for one building in St. John's where the studs on some walls exhibited considerable corrosion. There were however cases where the bottom tracks exhibited extensive corrosion in the investigation areas. An example of bottom track deterioration is shown in Fig. 11.

Fig. 11 Bottom track corrosion as seen in St. John's, Toronto and Calgary

Where corrosion has been noticed, bottom tracks were the first ones to be affected.

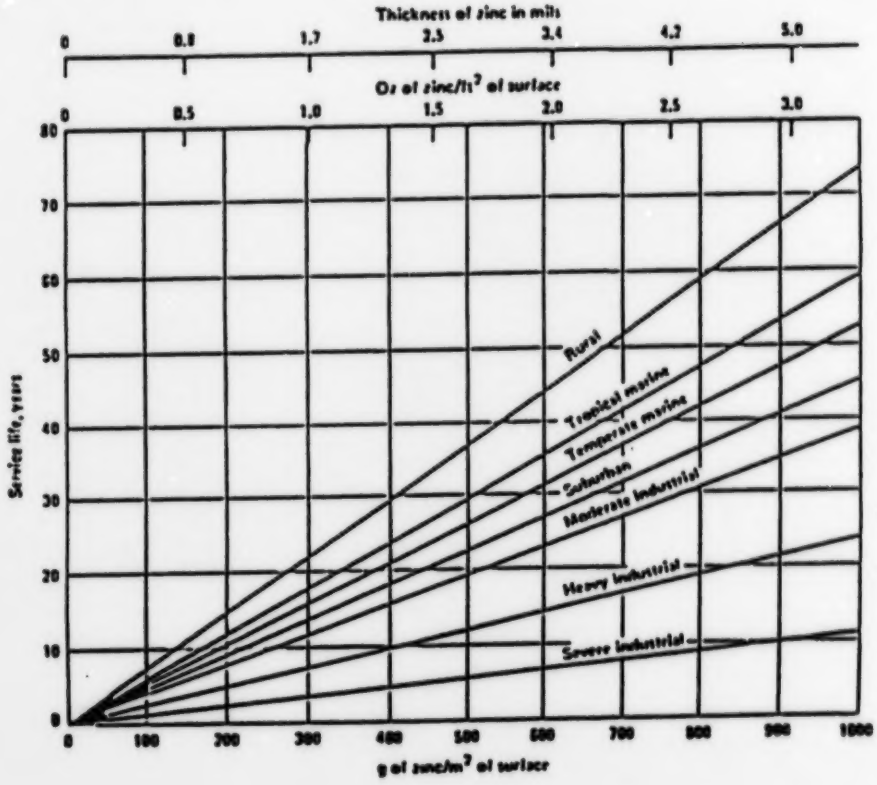
service life it appears that the coating thickness on the metal components tested are at the low end of the scale. Fig. 12 shows that for a coating thickness of 0.001 in. (0.025 mm) the underlying steel would be protected for about 15 years in a rural environment whereas an increase in coating thickness to 0.002 in (0.051 mm) or 0.003 in (0.076 mm) would increase the service life to say 30 years or 40 years, respectively. On the other hand, if the system is exposed to a more aggressive environment, a coating of 0.001 in. (0.025 mm) would protect the underlying steel for only a few years and a heavier coating would still only provide about 5 to 8 years of protection. This indicates the absolute need to stop the ingress of moisture or to improve the protection of vulnerable steel components.

Service life is measure in years to the appearance of first significant rusting.

Fig. 12 Effects of Amount of Zinc on Service Life of Galvanized Sheet (ASTM Handbook)
